BRUSH CREEK RESERVOIR, JENNINGS COUNTY

NORTH VERNON MEETING
JANUARY 22, 2004

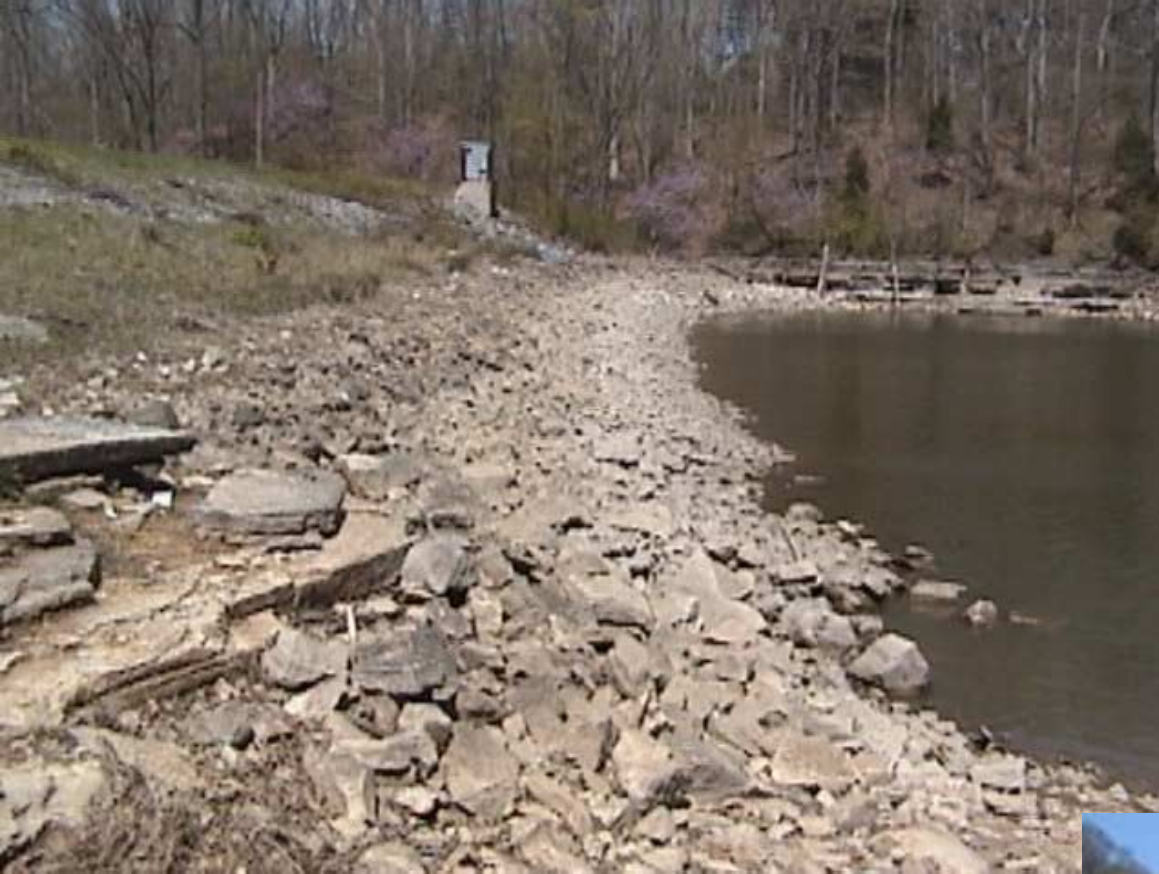
Brush Creek Dam

Looking north, from the left abutment

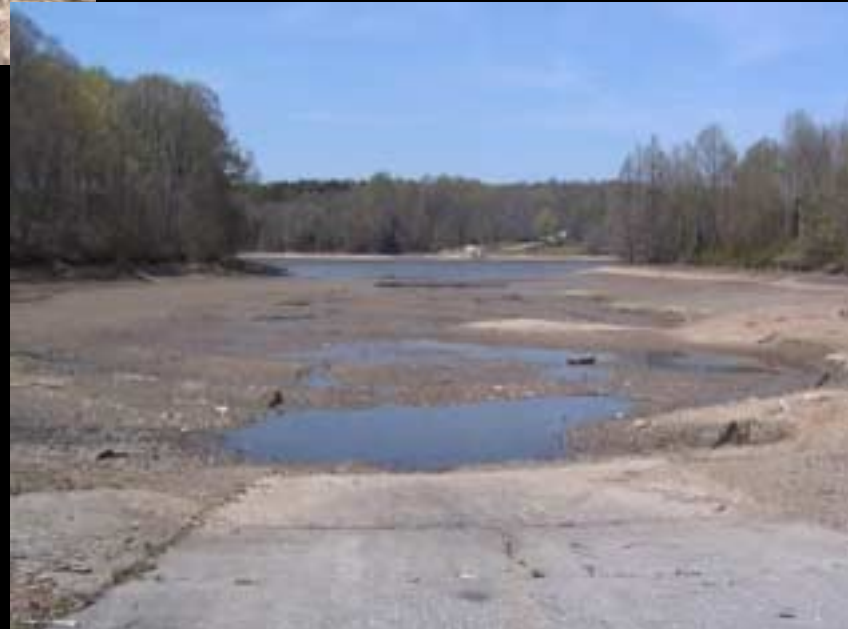
Brush Creek Reservoir

Public access site with reservoir level ~9' below normal pool

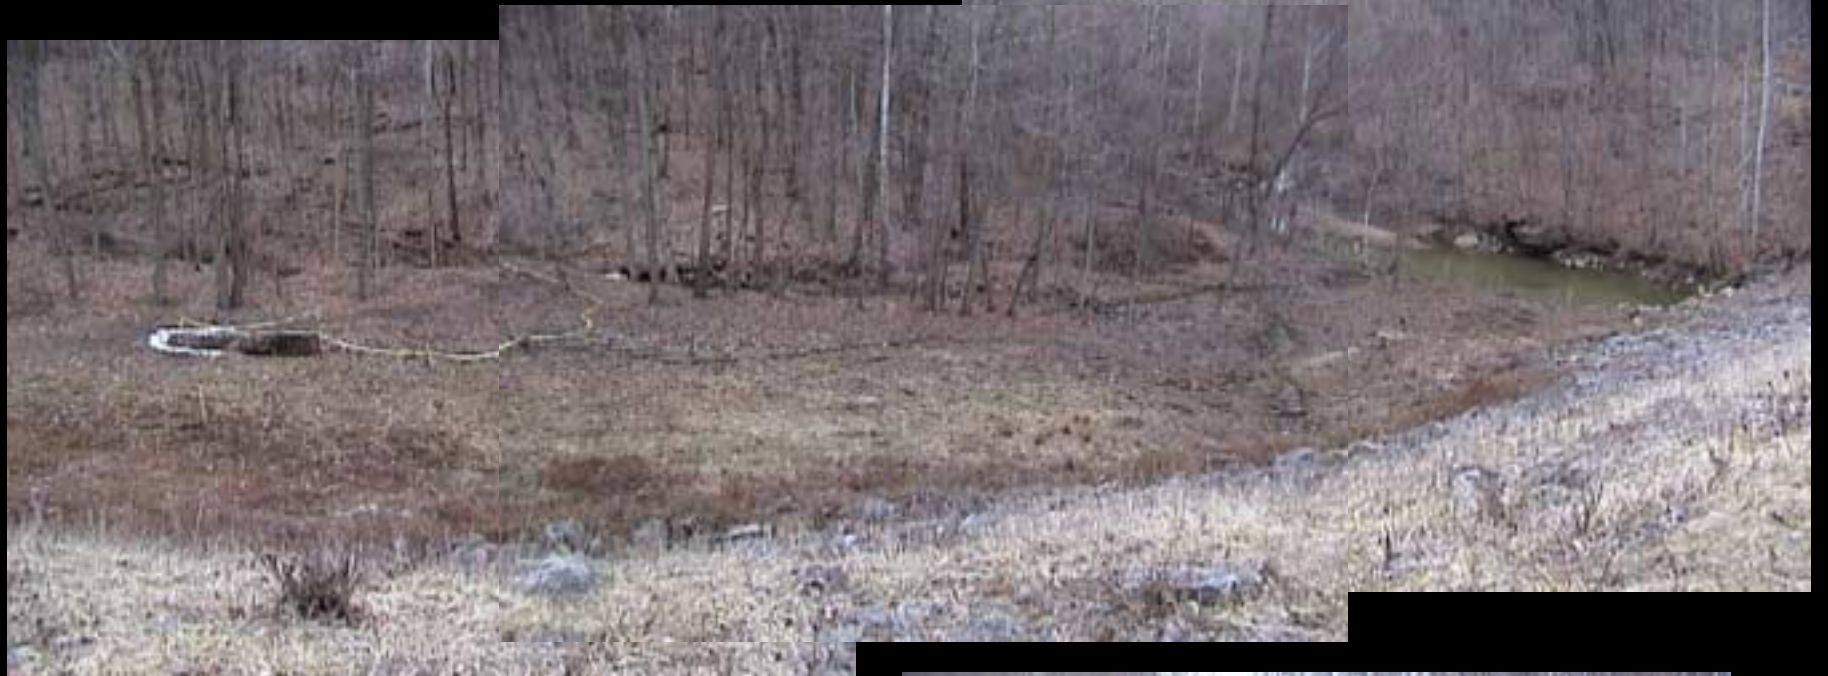
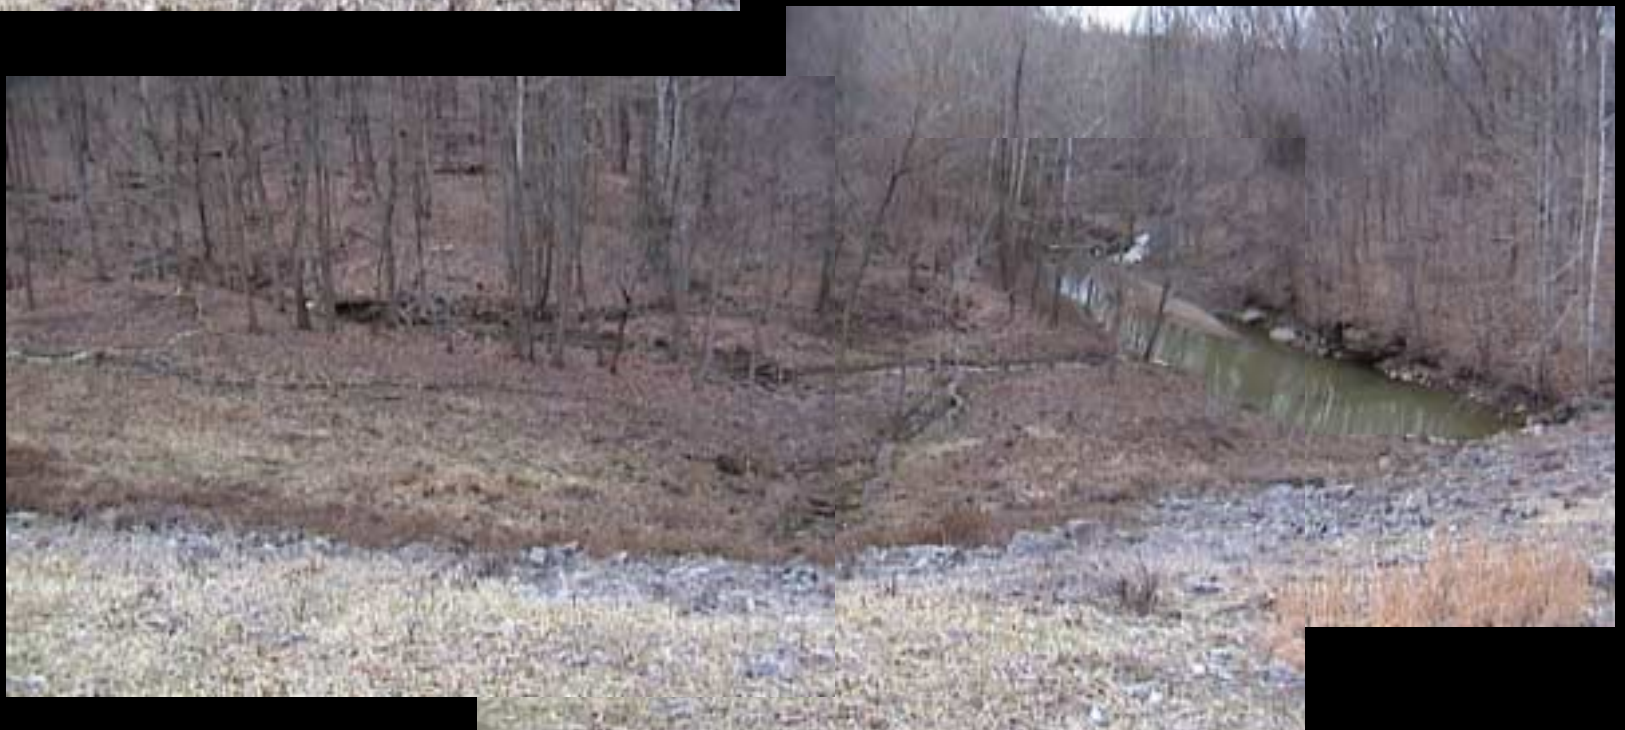
Brush Creek Dam

looking south, from the right abutment
